# Manhole Inspection Summary

Manhole # S43I2\_007MH

Insp Date: **1/7/08 10:01 AM**

**Location** Address: **1200 Church St**

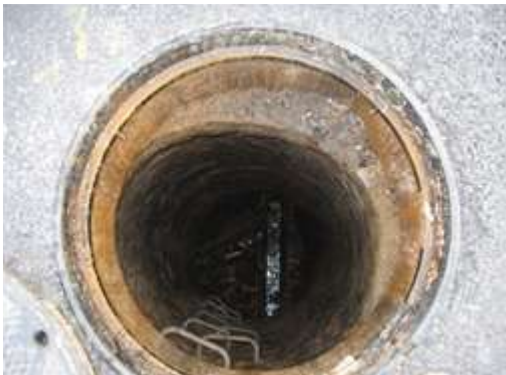
Top View

steps

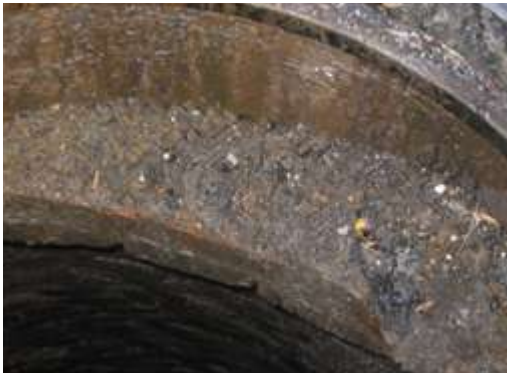
frame offset

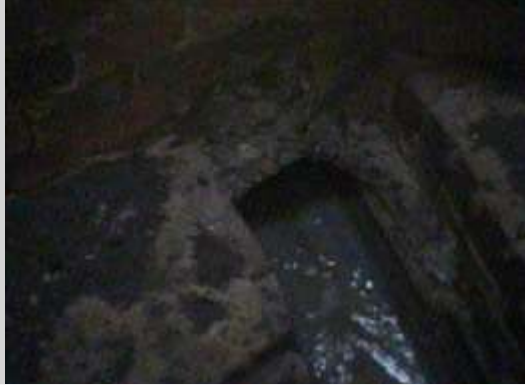
12 O'Clock Outflow

8 in. Circular Gravity Sewer  
Pipe Out @ 12 O'Clock

Pipe Height: **8.4** (in.) Rod and Bar (Angled)  
Pipe Material: **Clay** ☐ Pipe Lined  
Invert Depth: **17.16** (ft.) Flow Characteristics: **Fast**  
Deposits: ☒ None ☐ Mud ☐ Sludge ☐ Debris ☐ Grease  
Silt Depth: (in.) Deposits Extent:  
Infiltration: **None** Pipe Seal Cond: **Sound**

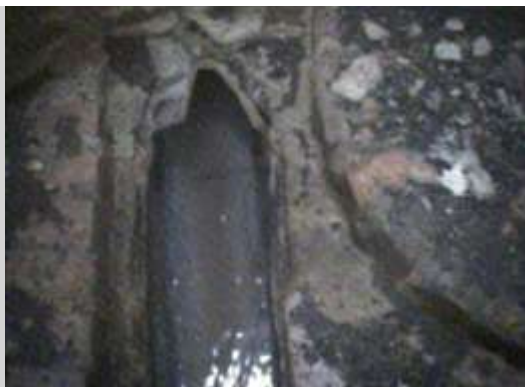
6 O'Clock Inflow

8 in. Circular Gravity Sewer  
Pipe In @ 6 O'Clock

Pipe Height: **8.4** (in.) Rod and Bar (Angled)  
Pipe Material: **Clay** ☐ Pipe Lined  
Invert Depth: **17.16** (ft.) Flow Characteristics: **Fast**  
Deposits: ☒ None ☐ Mud ☐ Sludge ☐ Debris ☐ Grease  
Silt Depth: (in.) Deposits Extent:  
Infiltration: **None** Pipe Seal Cond: **Sound**

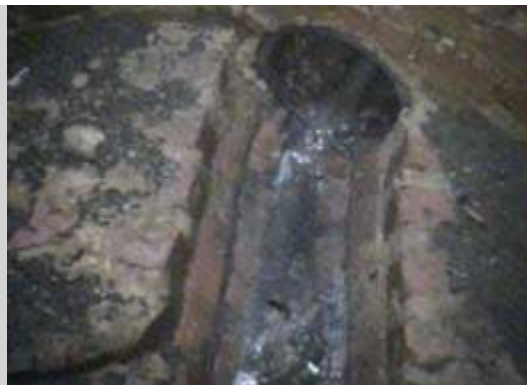
8 O'Clock Inflow

8 in. Circular Service Sewer  
Pipe In @ 8 O'Clock

Pipe Height: **8.4** (in.) Rod and Bar (Angled)

Infiltration: **None** Pipe Seal Cond: **Sound**
